# **Intel<sup>®</sup> Mobile Pentium<sup>®</sup> II Processor Specification Update**

Release Date: July 2000

Order Number: 243887-022

The Mobile Pentium<sup>®</sup> II processor may contain design defects or errors known as errata which may cause the product to deviate from published specifications. Current characterized errata are documented in this Specification Update.

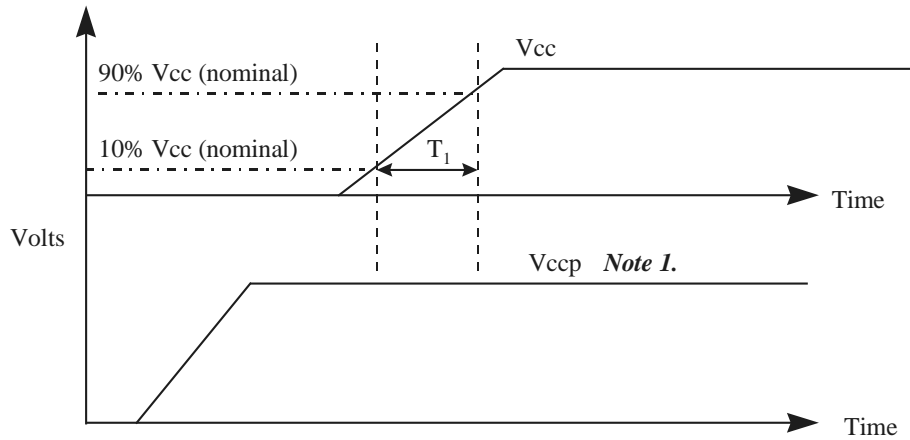
**Figure 1.  $V_{CC}/V_{CCP}$  Timing Requirements (Mobile)**

**Problem:** The processor uses the PWRGOOD signal to ensure that no voltage sequencing issues arise; no pin assertions should cause the processor to change its behavior until this signal is asserted, when all power supplies and clocks to the processor are valid and stable. However, if  $V_{CC}$  ramps up before  $V_{CCP}$ , it will cause the processor to enter an invalid state.

**Implication:** If this erratum occurs, the system may boot normally however, the L2 cache may not be initialized.

**Workaround:** For Mobile Pentium II processors, ensure that  $V_{CC}$  ramps after or with the L2 cache IO voltage ( $V_{CCP}$ ). If  $V_{CCP}$  ramps after the  $V_{CC}$ , a delay circuit can be placed on the core  $V_{CC}$  to ensure that  $V_{CC}$  ramps at the same time or after  $V_{CCP}$  as shown below in Figure 1.

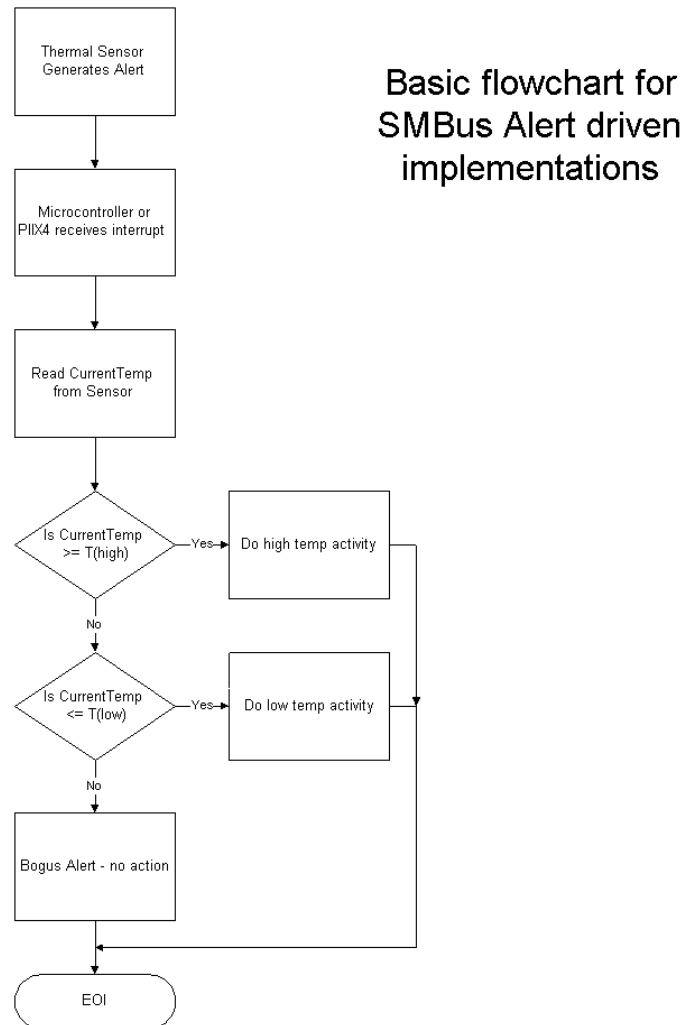
**Figure 2. Workaround Flowchart: SMBALERT#-Driven System**

Under the conditions described below, the thermal sensor incorrectly generates the SMBALERT# interrupt. All of the following conditions must be met to trigger a false interrupt:

1. Before servicing an interrupt from the thermal sensor, read and compare the processor thermal reading with the threshold limits ( $T_{HIGH}$  or  $T_{LOW}$ ). Figures 2 and 3 provide basic flowcharts for the implementation of this workaround in an interrupt driven system.
2. If the firmware implemented polls the Status Register only, then before taking any action, re-read the temperature register and do a comparison with the alarm threshold limits ( $T_{HIGH}$  or  $T_{LOW}$ ) to determine if the value is actually still within the temperature window.

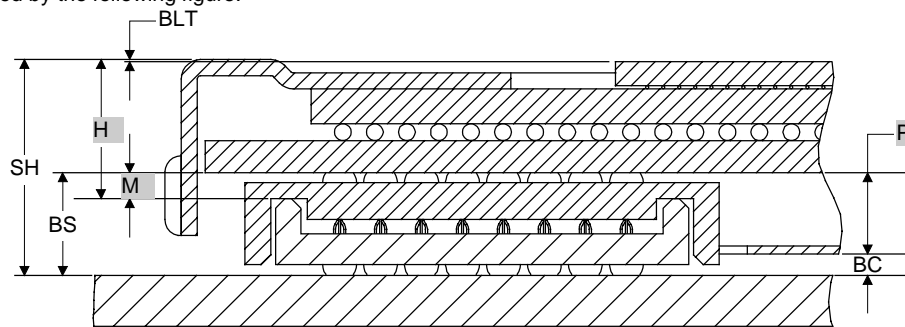
**Figure 5.6. Cross Sectional View with Vertical Dimensions**

### B1. Misabeled Vertical Dimension Parameters

Figure 5.6 in the *Mobile Pentium® II Processor at 233 MHz, 266 MHz, and 300 MHz* datasheet should be replaced by the following figure:
